Paper #: Power2008-60056

IMPROVING BOILER RELIABILITY THROUGH NDT

Shawn Gowatski
TesTex, Inc.
Pittsburgh, PA, USA

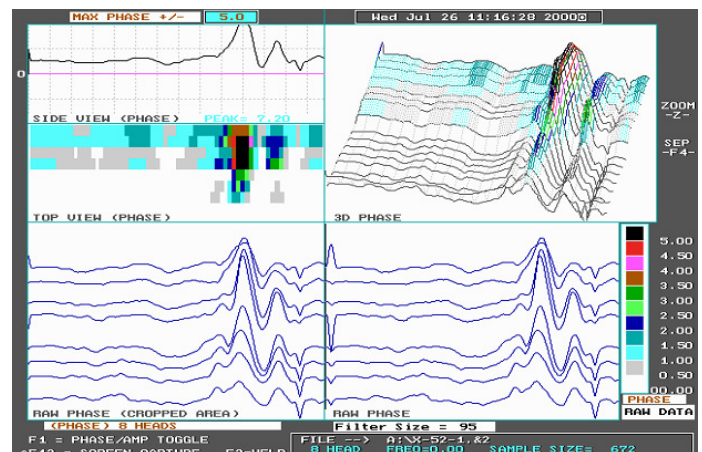
The Valmont Station had a planned outage in May 2000. Hard scaffolding was erected in the furnace and the tubes were cleaned with a high-pressure water blast. This method of cleaning removed the ash deposits and left the tubes with a uniform surface scale that allowed the LFET scanner to travel across smoothly. Please note the tubes were not sandblasted down to white metal. This saved time and money since LFET only requires the tubes to be smooth. As stated previously, LFET does not require any couplant nor a bare metal surface for a quality inspection. A total of 32,500 linear feet was inspected with LFET on four walls including the bullnose. Forty-five defects were found. Xcel Energy personnel inspected these defects with the Ultrasonic Tangential L-Wave Velocity Shift method. This method confirmed hydrogen damage was present in several tubes. The tubes with hydrogen damage were removed. This inspection took a crew of eight men four days to complete.

Figure 4 shows a waveform of a tube with confirmed hydrogen damage that was inspected during the May 2000 outage. The carbon steel tube dimensions are 2.5" O.D. with a wall thickness of 0.203".

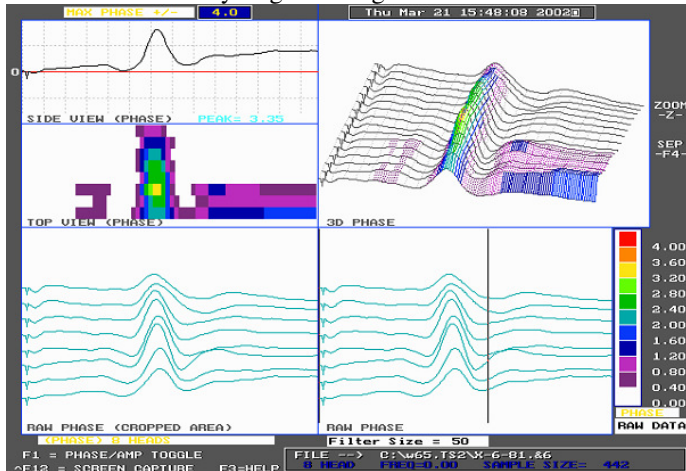
The Xcel Energy – Valmont Station had an outage in March 2002 and hard scaffolding was erected in the boiler again. Approximately 30,000 linear feet was inspected with LFET. The inspection identified 209 defects with ten of these defects containing hydrogen damage that were confirmed using the Ultrasonic Tangential L-Wave Velocity Shift method. The LFET Inspection took eight men four days to complete. Please note that Figure 5 shows a waveform of a tube that contained hydrogen damage with no wall loss present. The micro cracking from the hydrogen damage causes the electromagnetic signal to distort.

Figure 5 shows a waveform of a tube with nominal wall but with hydrogen damage. This waveform was collected during the March 2002 inspection. The carbon steel tube dimensions are 2.5" O.D. with a wall thickness of 0.203".

Structural Integrity used the "Time of Flight Diffraction" (TOFD) technique to inspect the butt welds. Thirty-seven of the butt welds showed hydrogen damage. The tubes with hydrogen damage were replaced along with some tubes that showed severe wall thinning. After this inspection, the unit ran

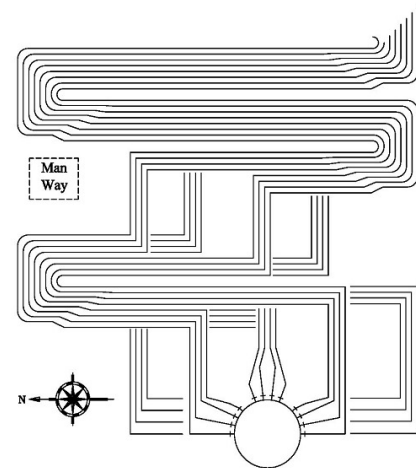
A power plant in western Pennsylvania experienced boiler tube failures in the horizontal reheater section in one of their boilers. The plant has three identically designed 835 MW coal-fired Foster Wheeler Units. Tube samples near the failures showed I.D. pitting approximately 3/16" in diameter on the bottom side of the tubes. Due to the design of the reheater, access to the bottom of the tubes was very limited. The tubes were 2.5" O.D., 0.180" wall thickness, with the material being SA-213T22.

Figure 6 shows a side view of the horizontal reheater.

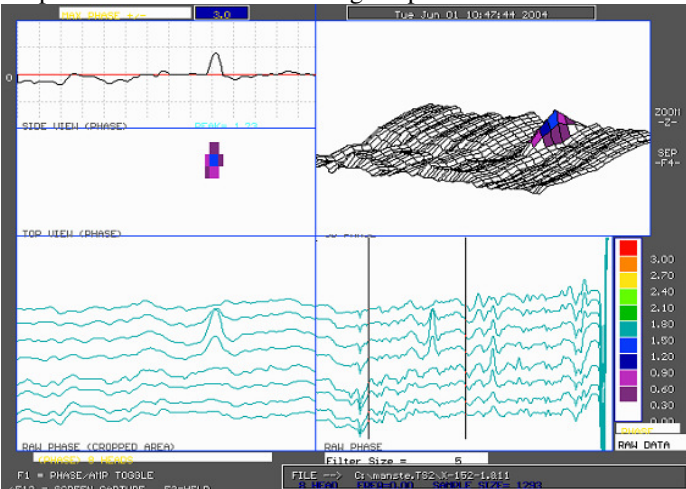
Figure 8 shows a waveform of a tube with a pit that has 25% wall loss. The tube dimensions are 2.5" O.D. SA-213T22 tube with a wall thickness of 0.180".

A total of 44 defects was found. The defects were marked. The areas with the most severe flaws were removed. Minor defects were pad welded. The low profile LFET scanners were able to identify pitting as shallow as 20% wall loss or a wall remaining of 0.144" out of 0.180". Some tubes had several pits over a 4' area while other tubes only showed a single pit. The repairs the plant made saved them from several forced outages.

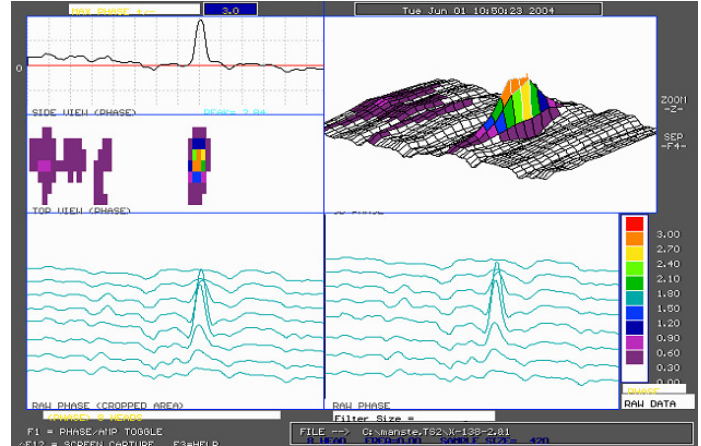
Figure 9 shows a waveform of a tube with a pit that has greater than 70% wall loss. The tube dimensions are 2.5" O.D. SA-213T22 tube with a wall thickness of 0.180".
