Paper #: POWER2008-60061

THE USE OF AN EDDY CURRENT INSPECTION OF BRASS TUBES IN A SURFACE CONDENSER TO PROVIDE A CONDITION ASSESSMENT

Shawn Gowatski
TesTex, Inc.
Pittsburgh, PA, USA

Tim Mitchell
Boralex Ashland
Ashland, ME, USA

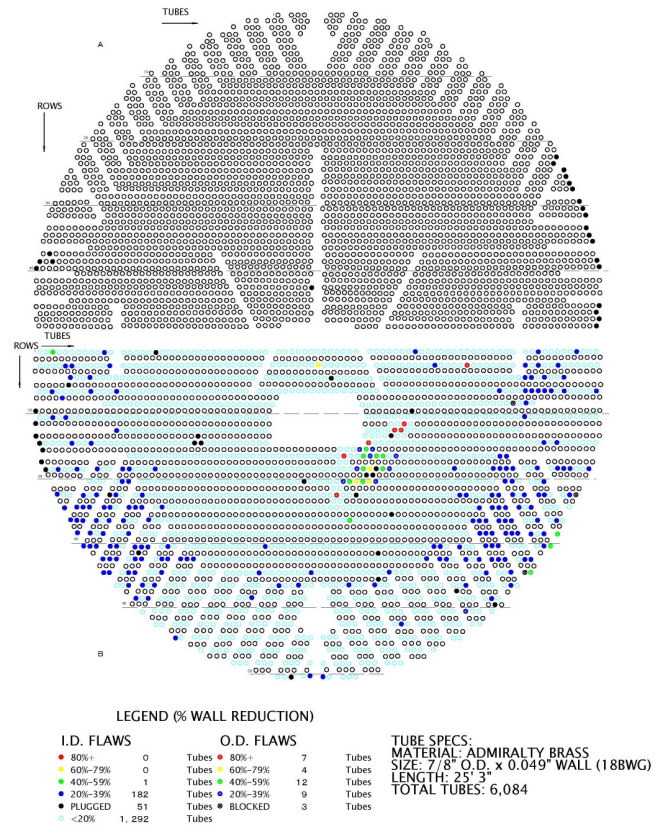
BORALEX ASHLAND
MAIN CONDENSER
VIEWED FROM SOUTH END

The color-coded tubesheet map is shown in Figure 5. Each circle represents a tube. The view is as one is looking at the South Tubesheet. The tubes colored in white were not tested. The black tubes are plugged. The light blue tubes showed less than 20% wall loss, dark blue showed 20-39% wall loss, green tubes showed 40-59% wall loss, yellow tubes showed 60-79% wall loss, and the red tubes showed greater than 80% wall loss. The map illustrates the location in the condenser where the most thinning is occurring.

Figure 5 shows the color coded Tubesheet Map detailing the condition of the tubes.

During the 2008 inspection of the surface condenser, the contractor found 7 tubes with greater than 80% wall loss and 4 tubes with 60-80% wall loss. The thinning found was on the OD of the tubes. The plant also performed a pressure test on the tubes and found four leaking tubes that were not part of the inspection scope. These four tubes along with the seven tubes with greater than 80% wall loss were mechanically plugged.

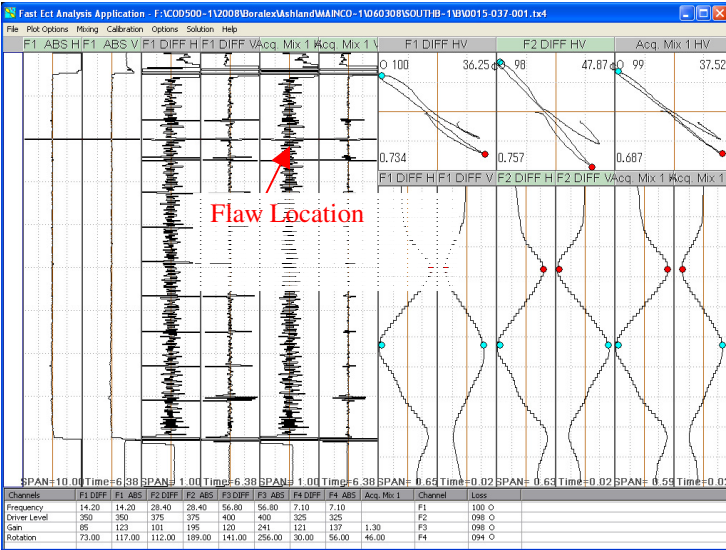
Figure 6 is a sample waveform collected from the main condenser at Boralex-Ashland. This particular tube, tube 15-37 (Bottom) indicated greater than 95% OD Wall Loss. The flaw is located at space 9 of the tube (between baffles 8 and 9).

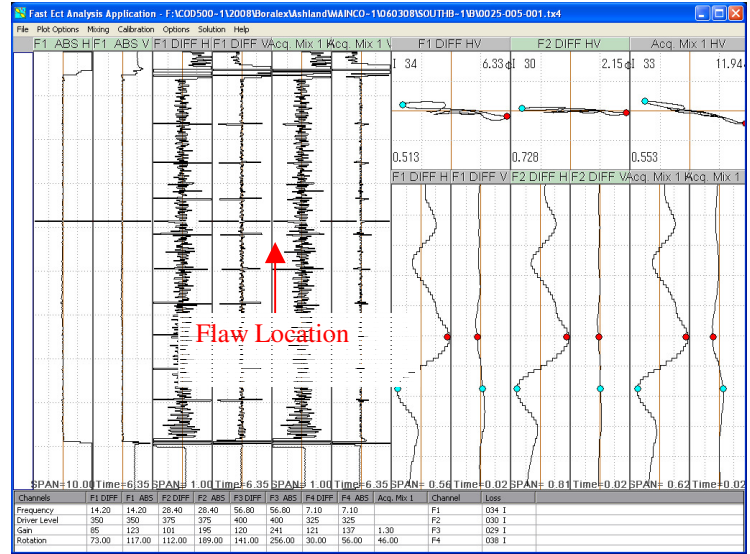
Figure 8 is a sample waveform collected from the main condenser at Boralex-Ashland. This particular tube, tube 25-5 (Bottom) indicated a 35% ID Wall Loss. The flaw is located at space 7 of the tube (between baffles 6 and 7).

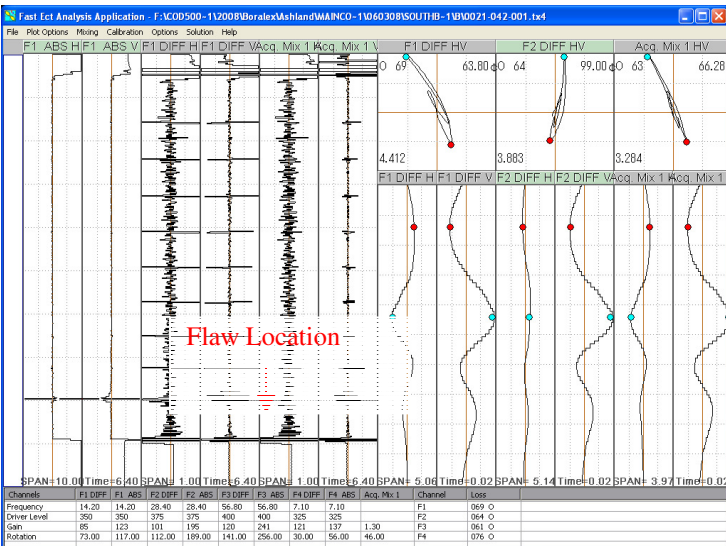
Figure 7 is a sample waveform collected from the main condenser at Boralex-Ashland. This particular tube, tube 21-42 (Bottom) indicated a 65% OD Wall Loss. The flaw is located at space 2 of the tube (between baffles 1 and 2).
