Low Frequency Electromagnetic Technique (LFET) Low Profile Scanner Helps Find Wall Loss in Boiler

STATE OF THE ART PRODUCTS AND SERVICES
FOR NON-DESTRUCTIVE TESTING

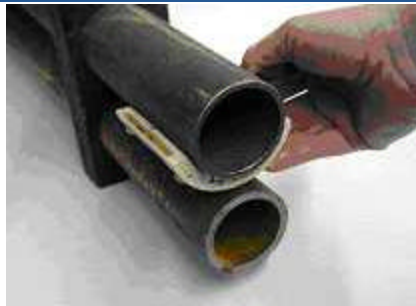
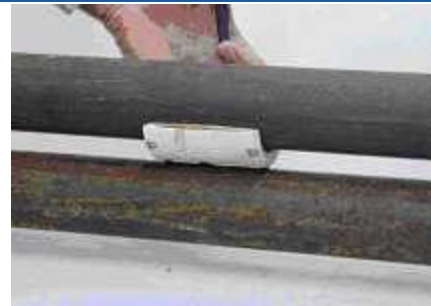
Inspection from the ID was not possible due to accessibility. In addition, the 90 and 180 degree bends would prevent a probe from negotiating the ID even if access was somehow provided. Each reheater pendant has eight tubes that are stacked on top of each other with approximately 1" of vertical clearance between the tubes. The only way to inspect the tubes was from the OD with a scanner less than 1" in height that could detect and size small ID pits. (See pictures below)

These pictures show the LFET Low Profile Scanner and the geometry of the reheater tubes.

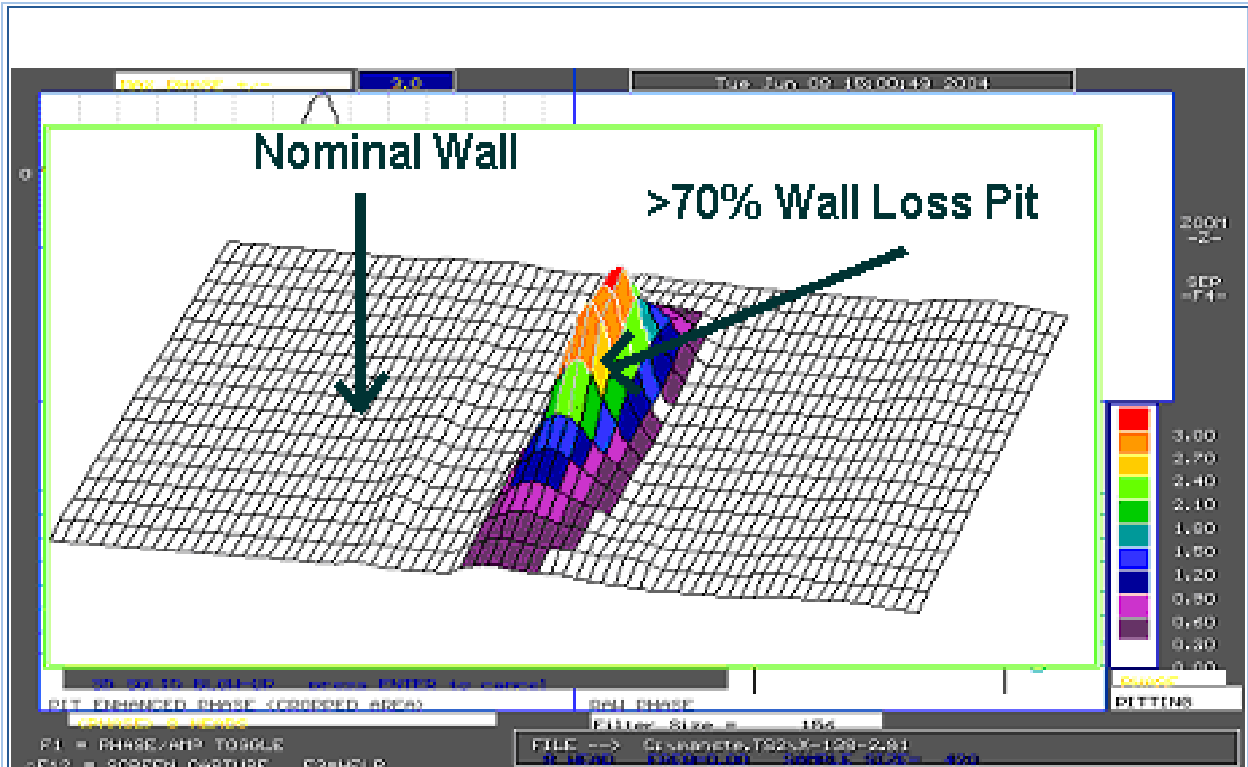
A total of 58 tubes were identified with pits ranging from 20-30% wall loss to >70% wall loss. A few of the tubes had several pits along a 3' area. A tube identified as having >70% wall loss was cut out. This cut-out contained a pit with less than .054" wall remaining or >70% wall loss.

This waveform shows a pit with >70% wall loss.

Fifty-eight flaws in the plant's Unit #3 Reheater were located and repaired with dutchmen or pad welds. Thus, 58 potential forced outages were avoided. According to plant personnel, it takes a minimum of 72 hours to bring the boiler down and repair a tube leak on the 700mw unit.
