Eagle 2000 Plus Multi-channel NDT System Discovers Pitting in Boiler Tubes at a Chemical Plant in Eastern Tennessee

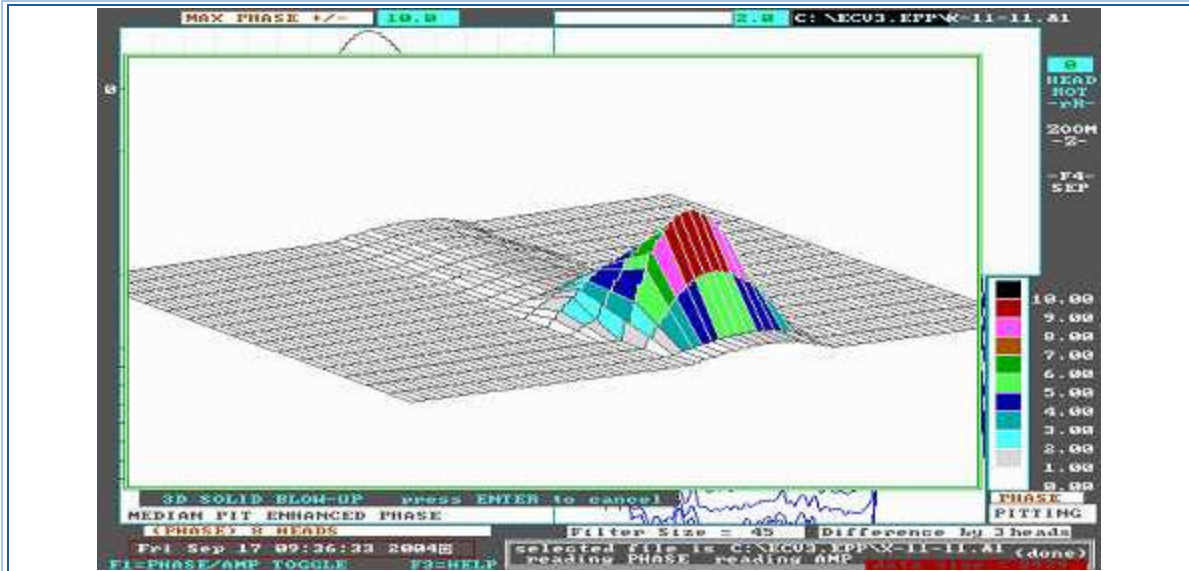
A total of 7 tubes were identified with pitting. The most severe indication exhibited >45% wall loss. The other 6 tubes exhibited between 20-25% wall loss. The tube identified as having >45% wall loss was proved-up using a boroscope.

This waveform shows the pit exhibiting >45% wall loss based on a nominal wall thickness of .165".
 This isolated pit was found between the mud drum tubesheet and bend.

All 7 flaws in the generating bank cold side were scheduled for plugging. This assessment of the cold side of the generating bank has minimized the potential need for a forced outage.

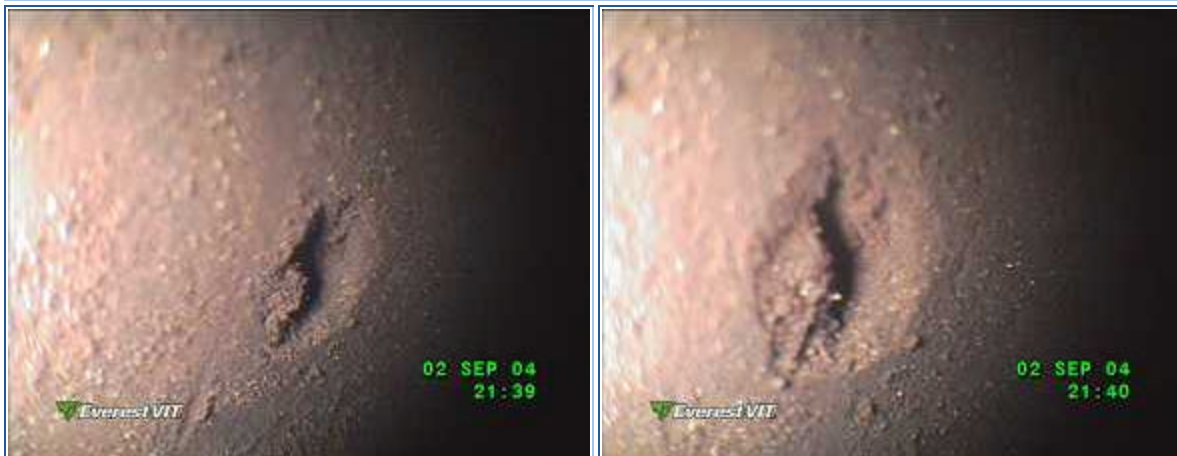
These pictures are the boroscope still shots, showing the isolated pit that was found exhibiting >45% wall loss using the [Eagle 2000 Plus Multichannel NDT System](#).
