CIRCULATING WATER LINE INSPECTION FINDINGS

TesTex has been performing inspections on Circulating Water Lines for power plants. The inspection consists of an API 570 certified piping inspector conducting a thorough visual inspection internally and externally as access permits. Ultrasonic thickness measurements are taken where accessible.

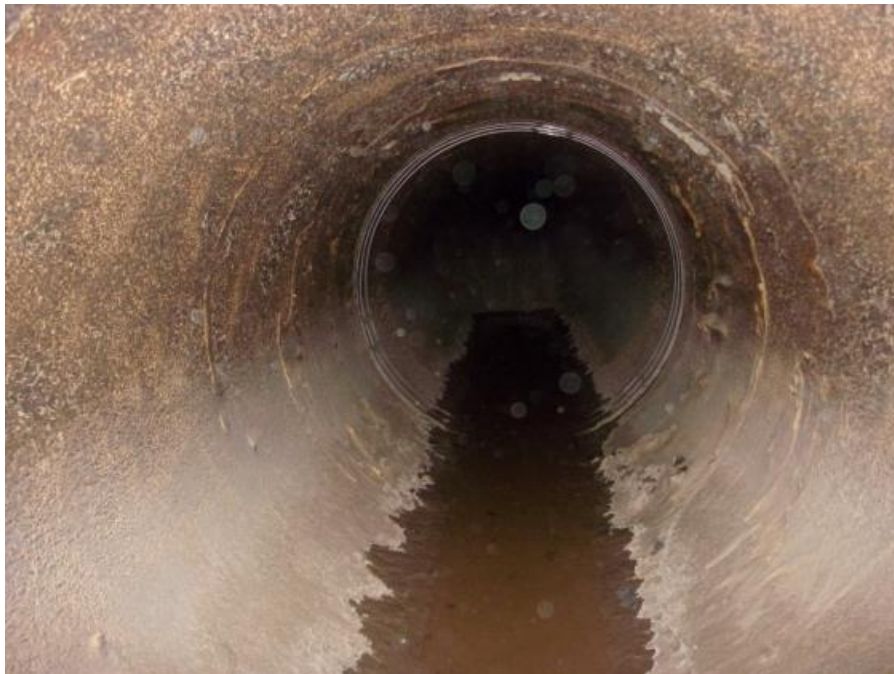
Circulating Water Line showing the concrete surface with coating in some areas

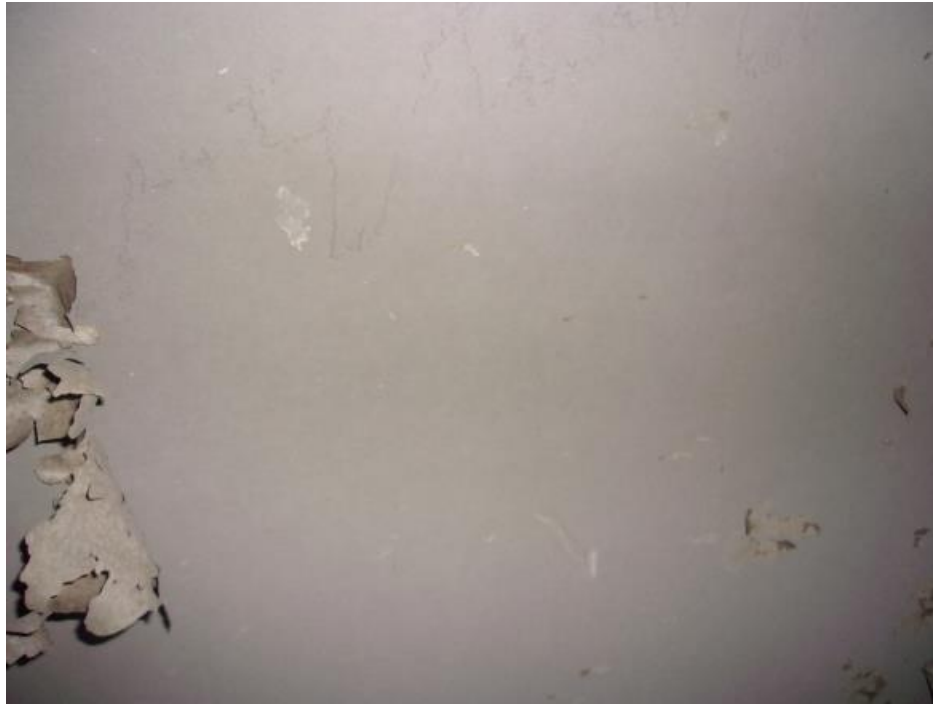
Coating on carbon steel section of pipe

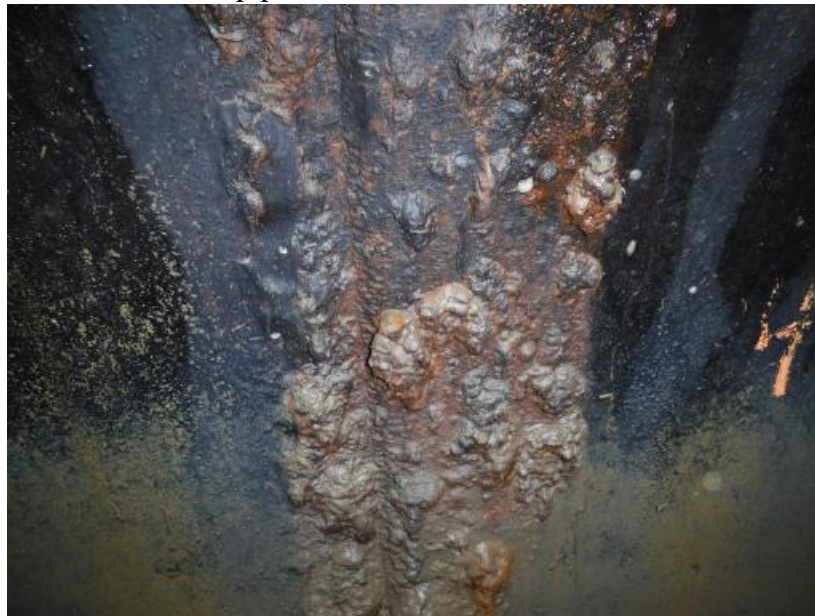
Junction of two carbon steel pipe sections where the coating has failed leading to the formation of corrosion blisters.

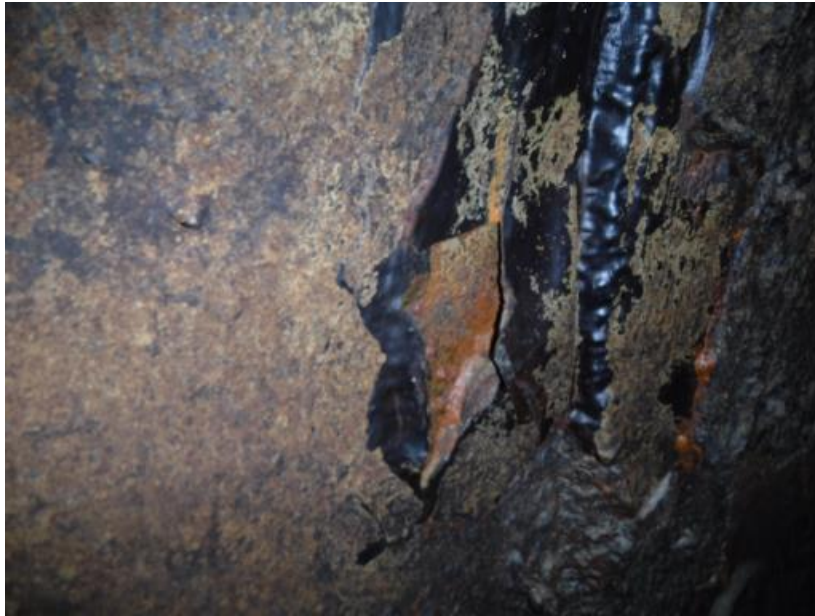
Damage to the coating of the carbon steel piping

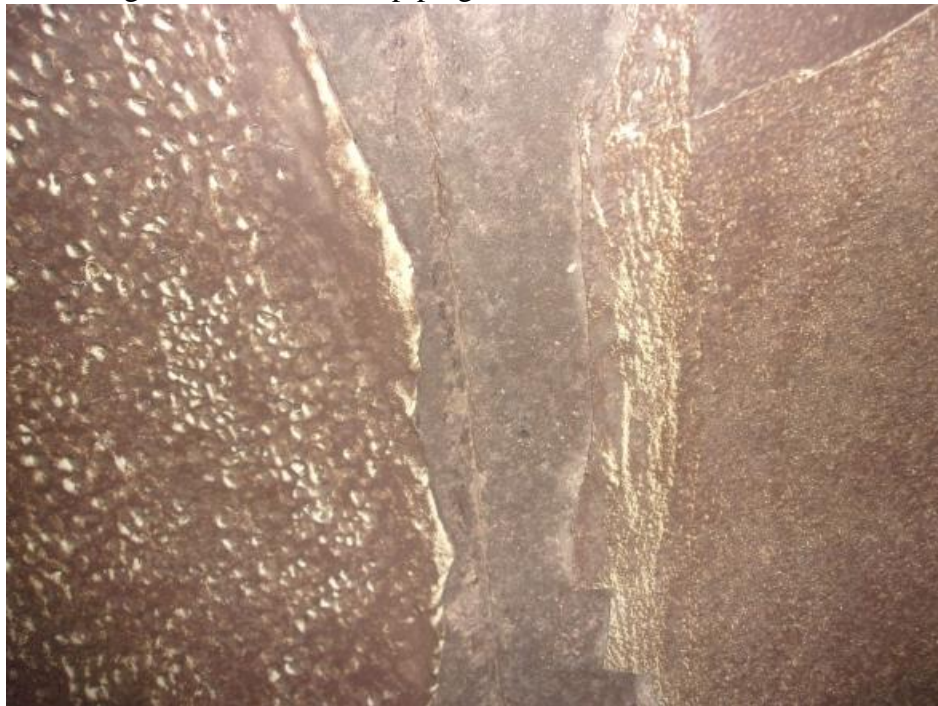
Coating Failure at a concrete joint

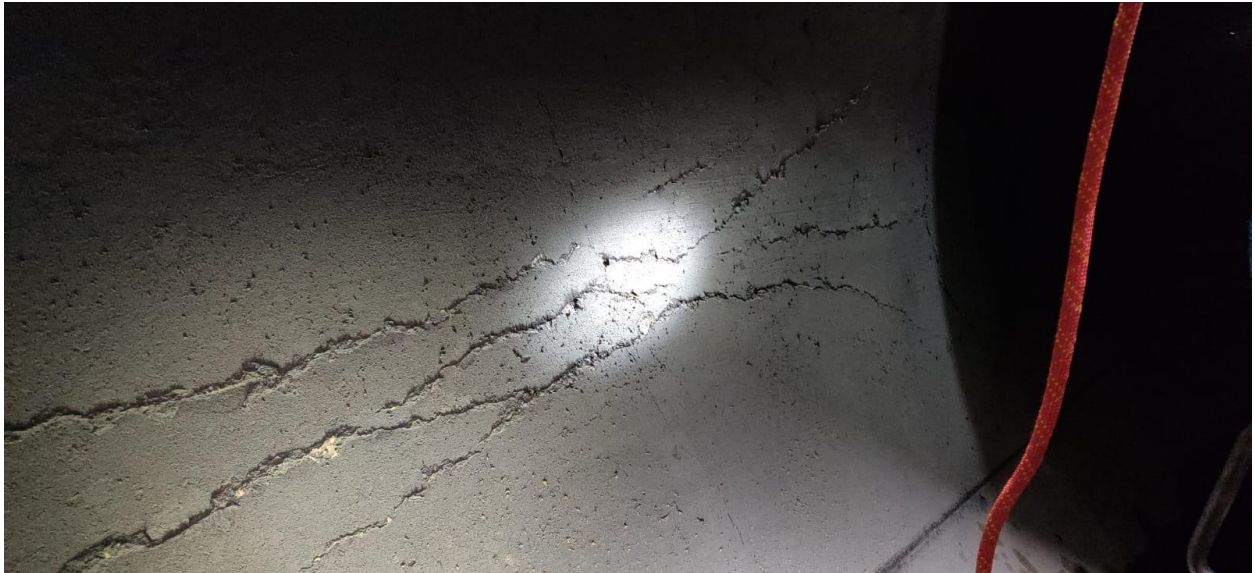
Axial Cracking on the concrete line pipe

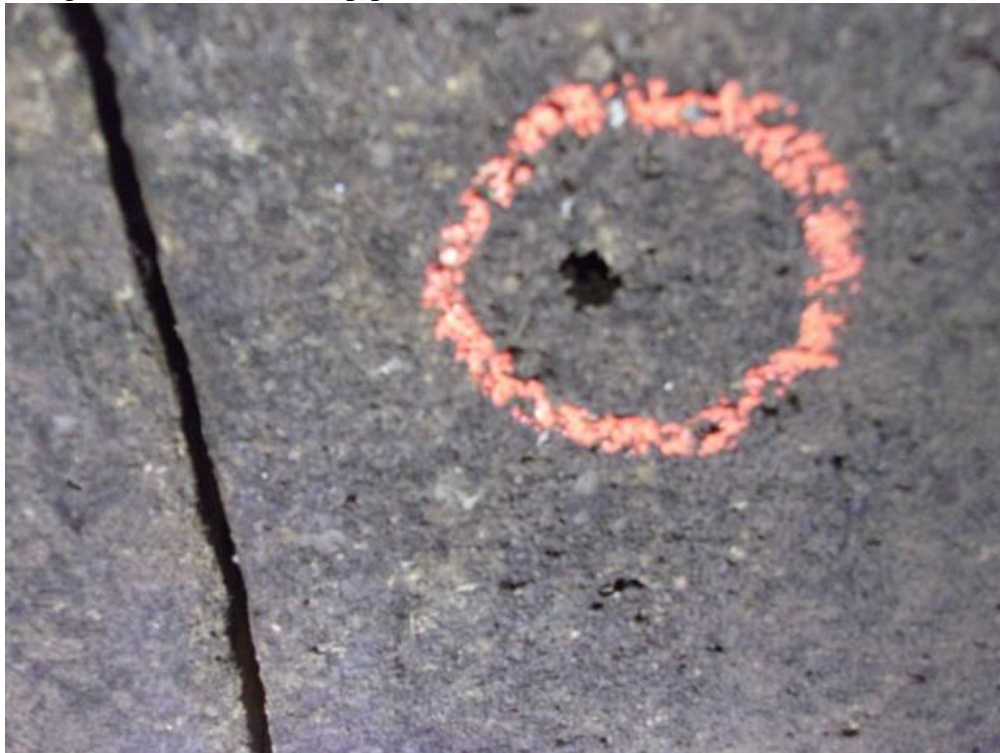
2" deep pit in concrete

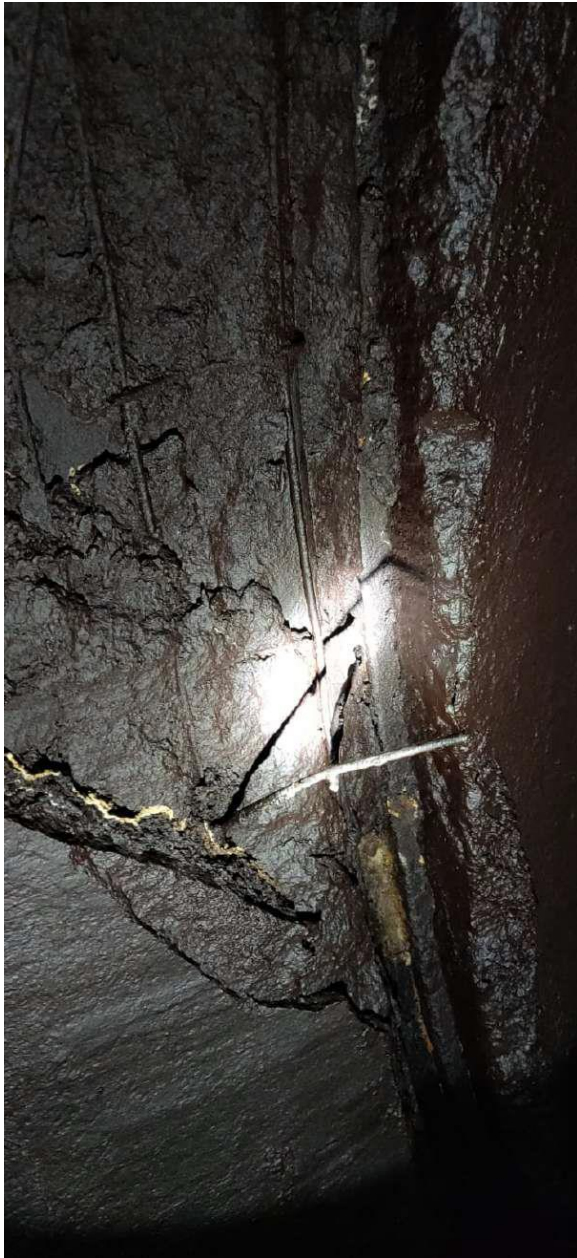
Broken prestressed wire at a bend

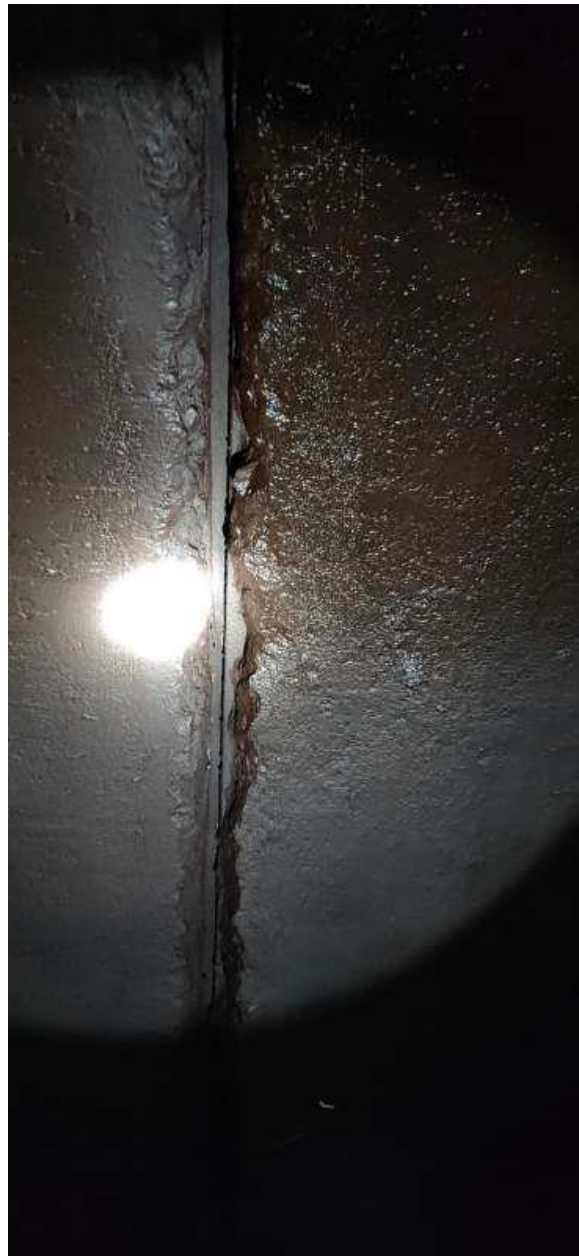
Cement Gap at a Joint

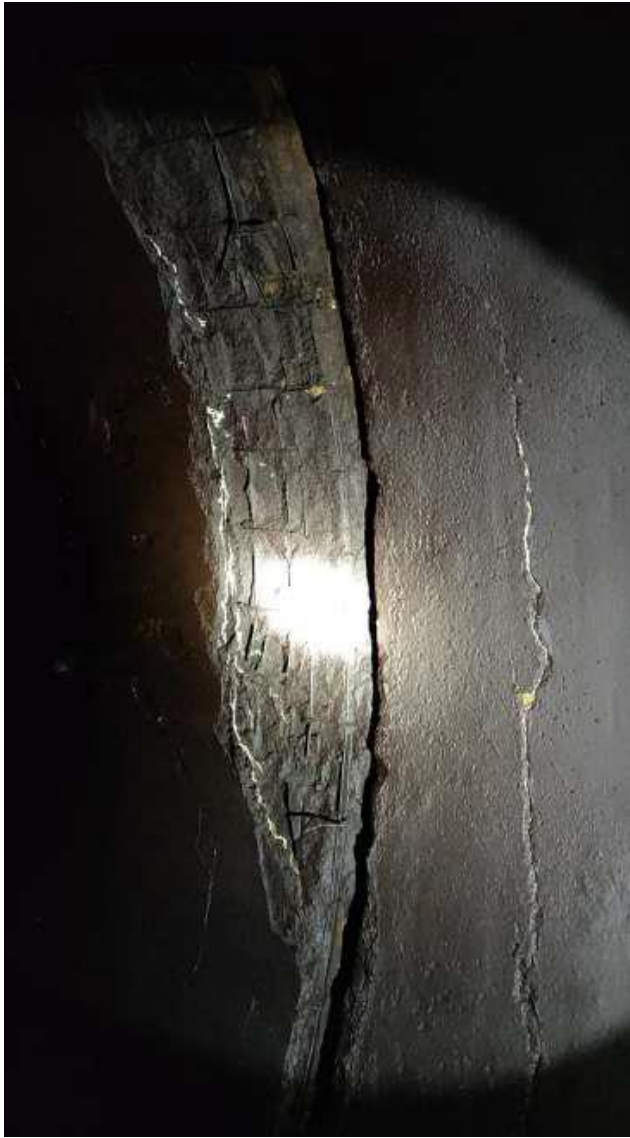
Cement Disintegration

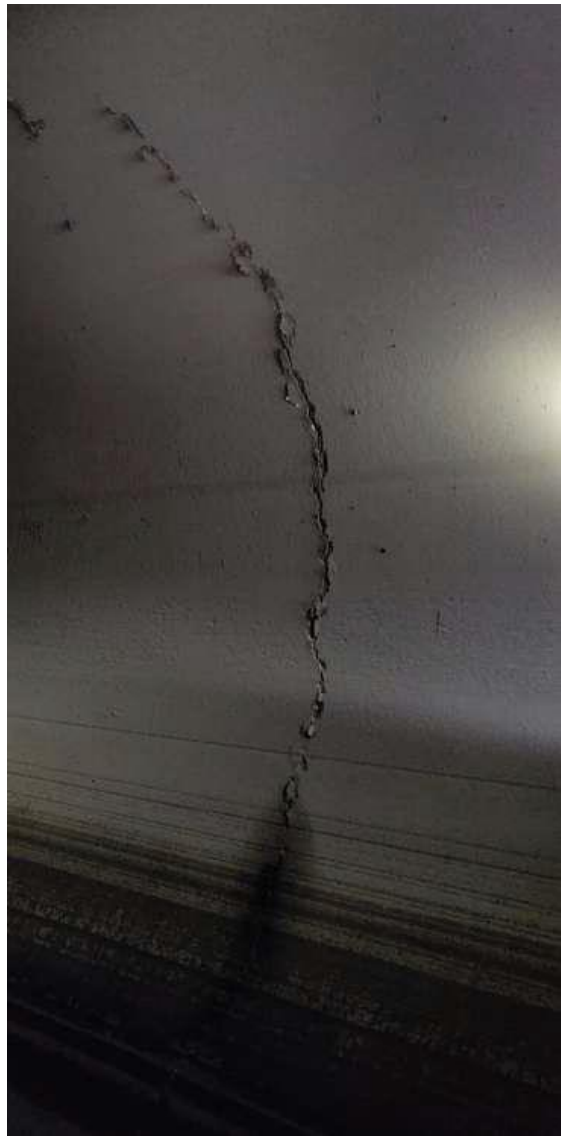
Circumferential Crack between joint 1 & 2

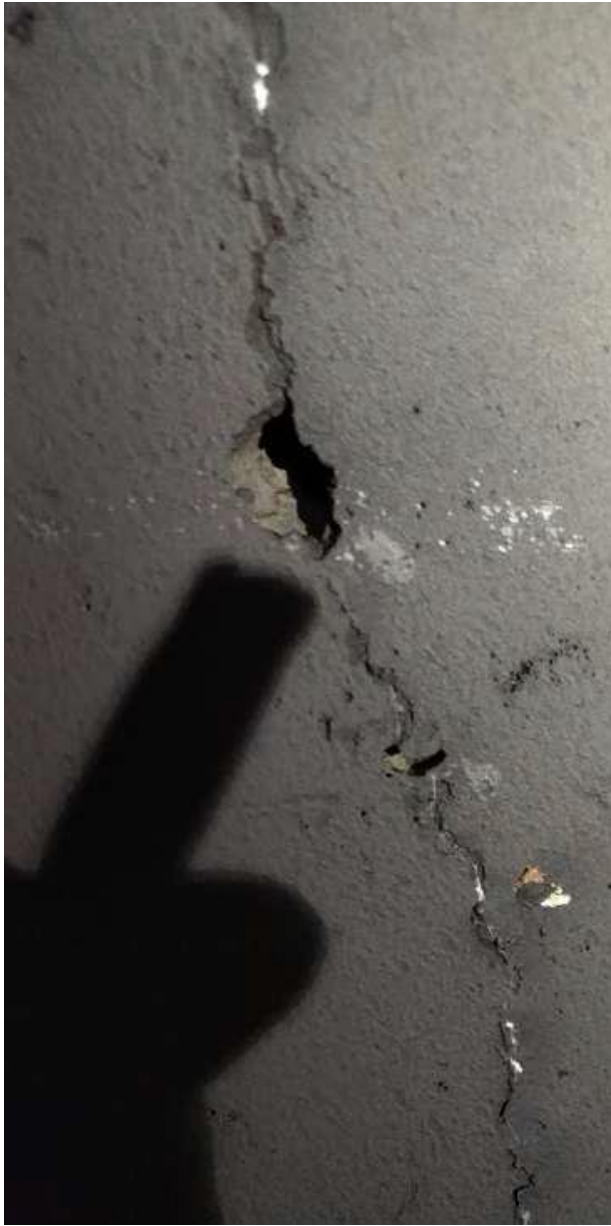
Cracking and Pitting on concrete liner

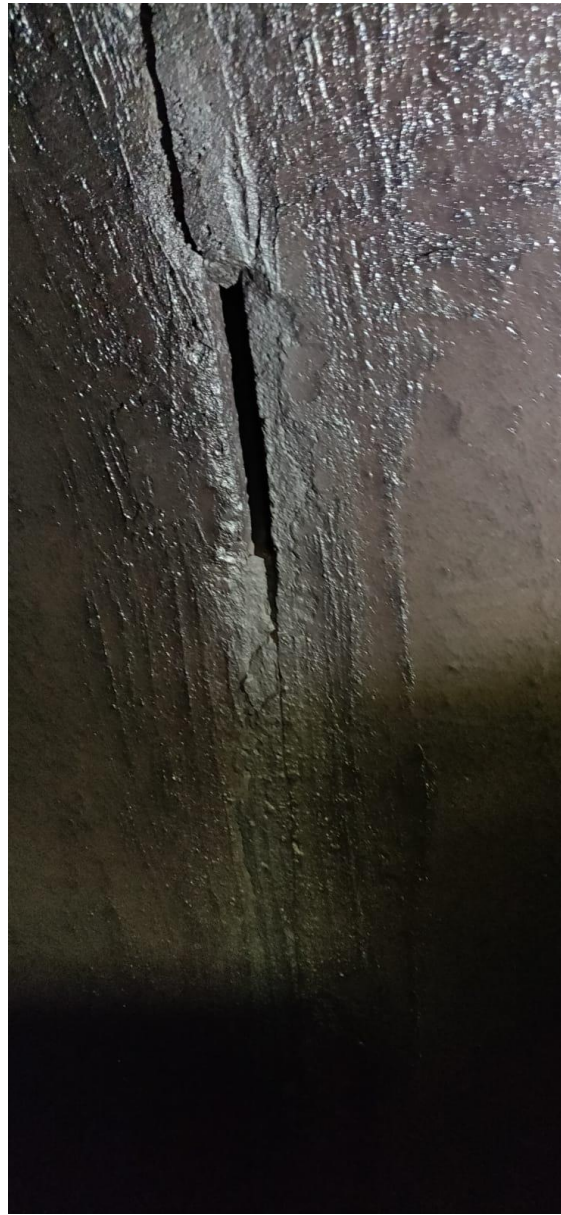
Concrete Gap at Joint

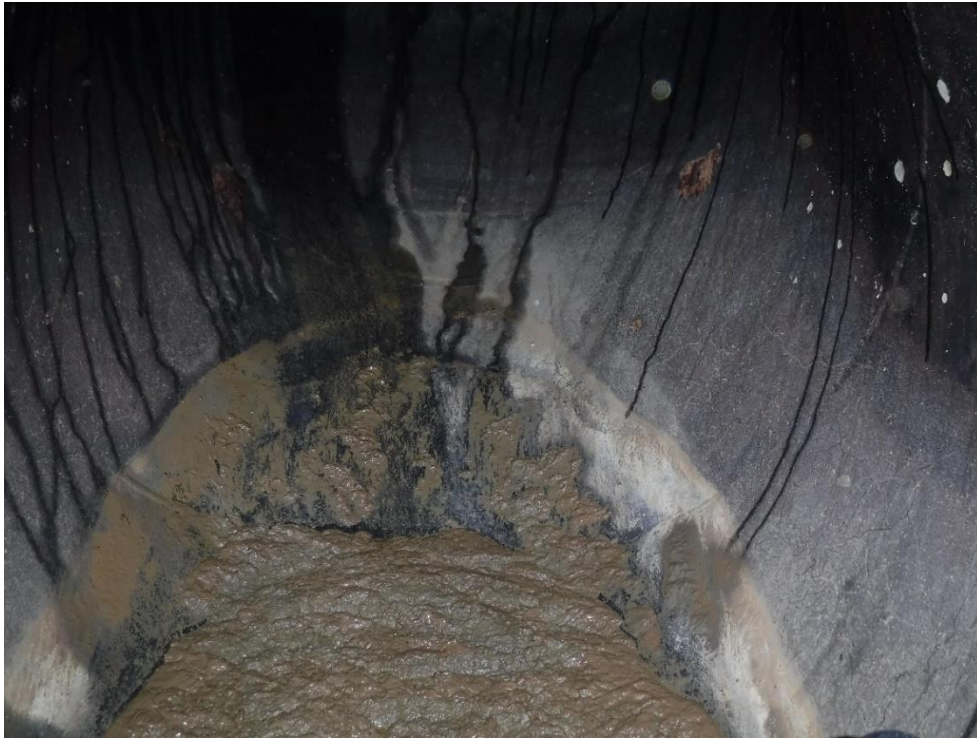
Excessive amount of mud found in Circulating Water Line.

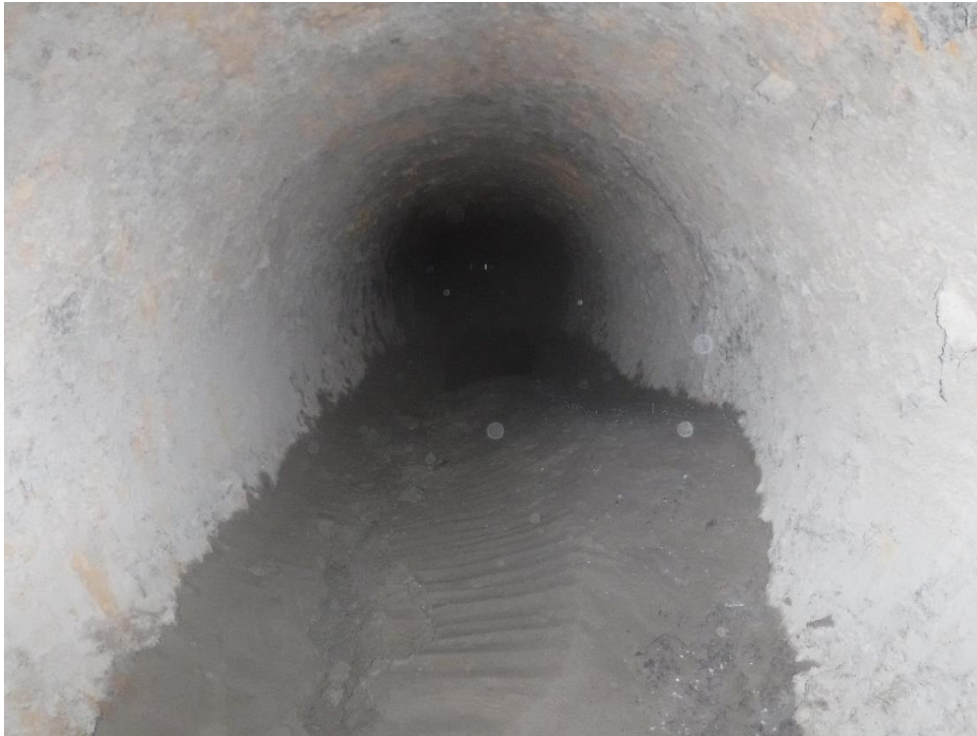
Photo shows the area with significant sediment buildup. This area is close to the condenser on the outlet side of the system.

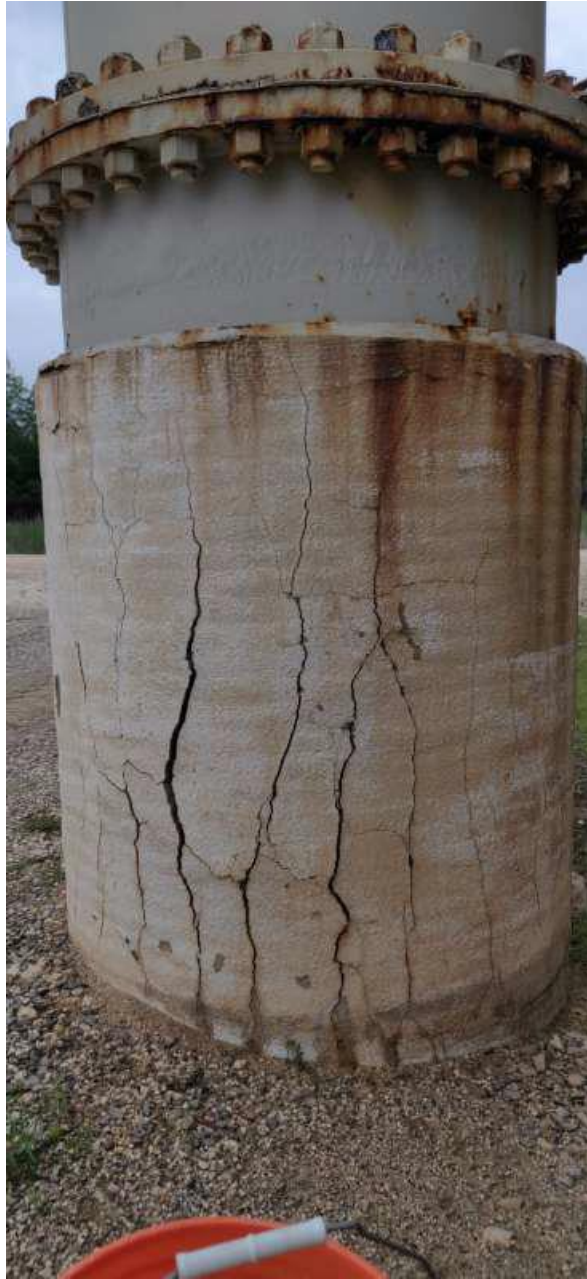
Deep Cracks in the Mortar coating on a Riser Pipe

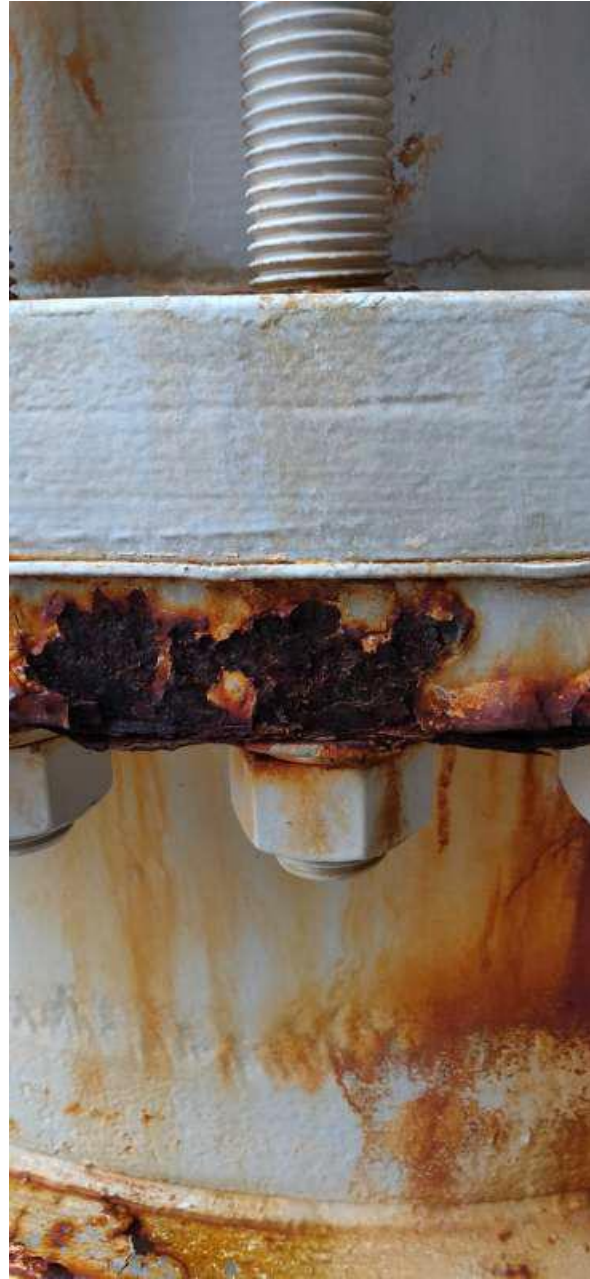
Corrosion Deterioration at flange

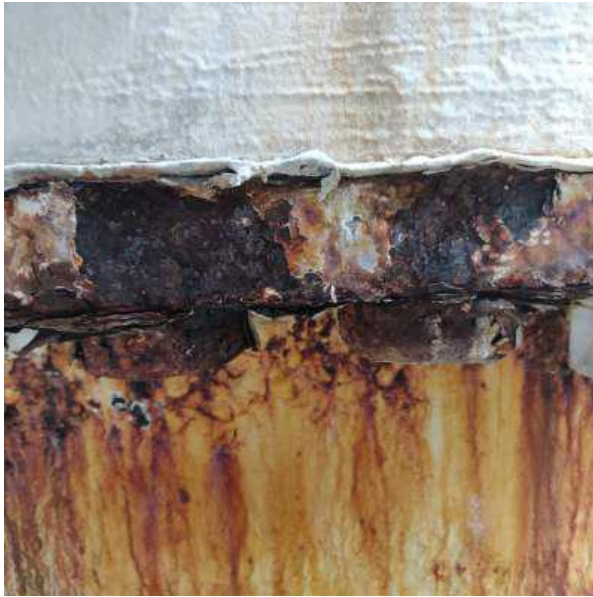
Coating Failure at a flange on the Riser Pipe

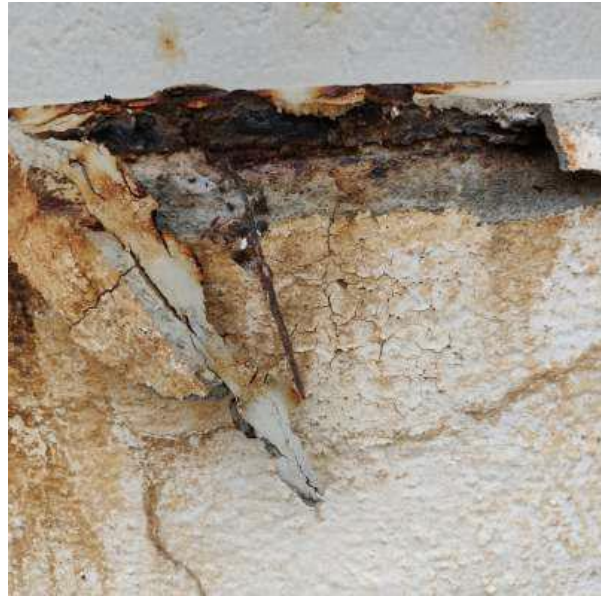
Prestressed wire exposed and broken on mortar coating of a Riser Pipe

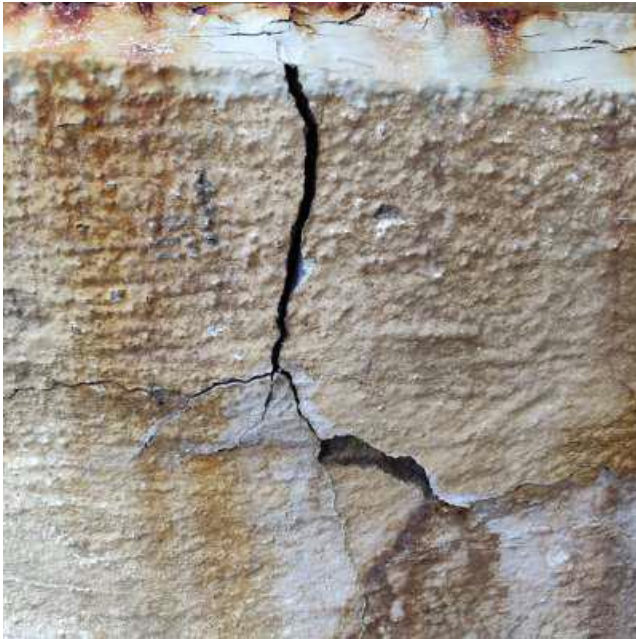
Deep Mortar Cracks on a Riser Pipe

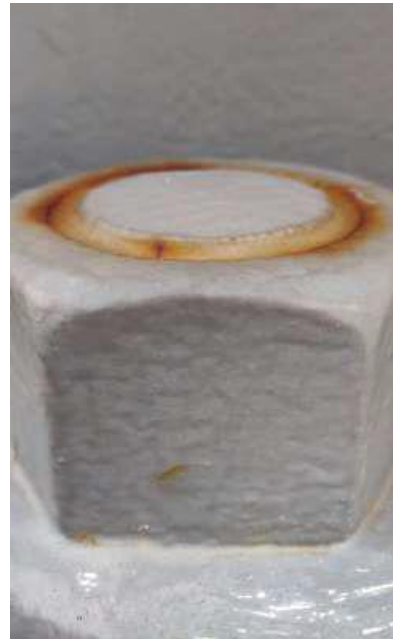
Lack of thread engagement on bolt at flange

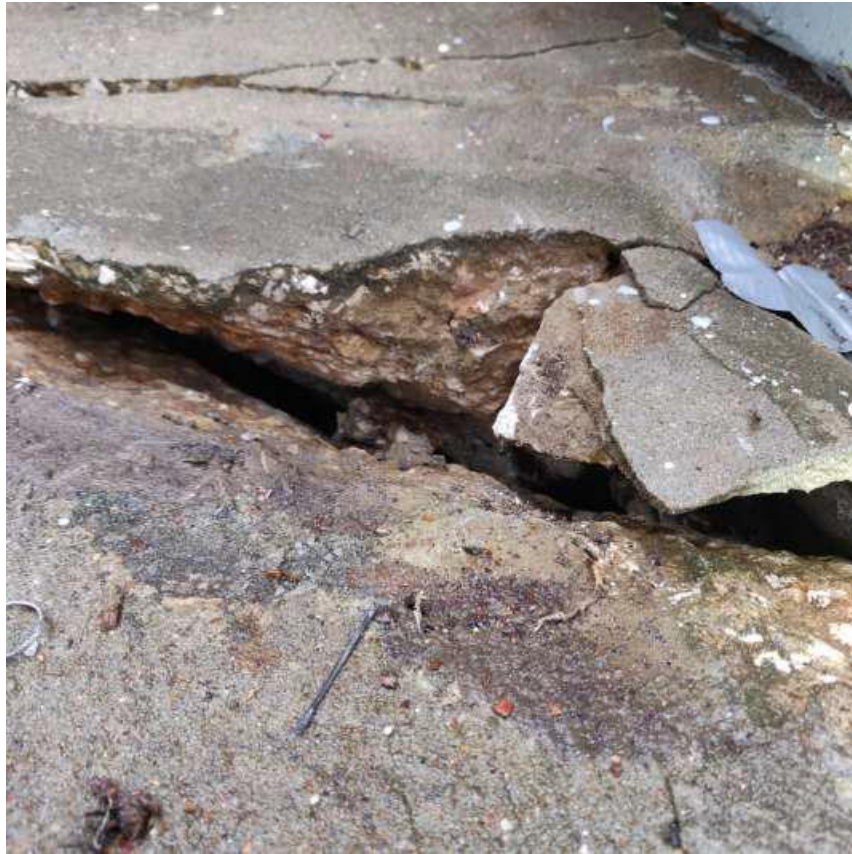
Cement base disintegration where Discharge pipe comes out of ground on Condenser side

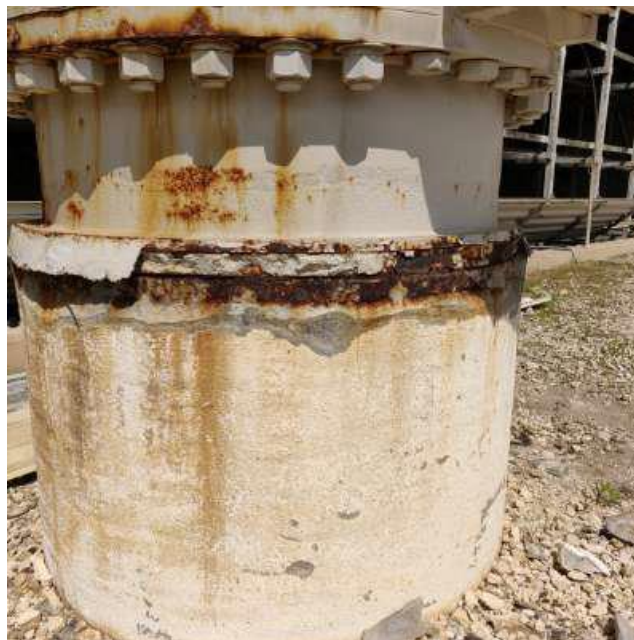
Mortar Coating failure on Riser B

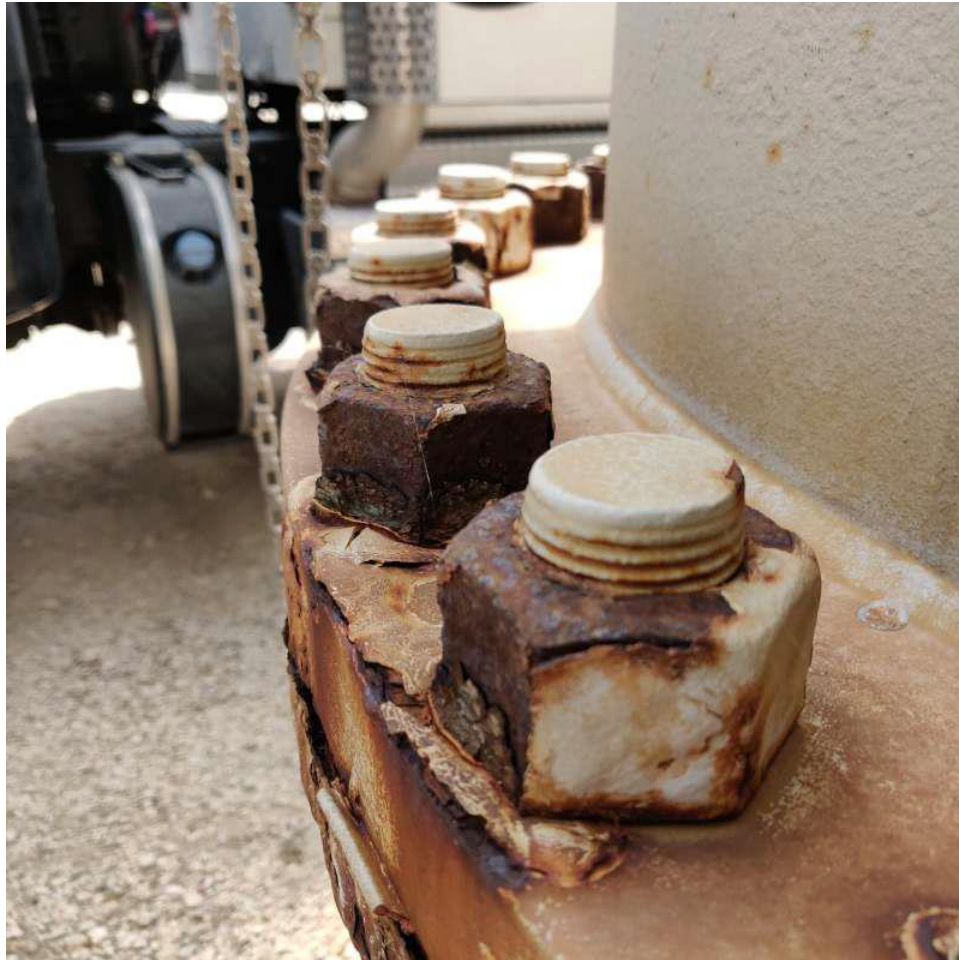
Severe bolt corrosion on flange

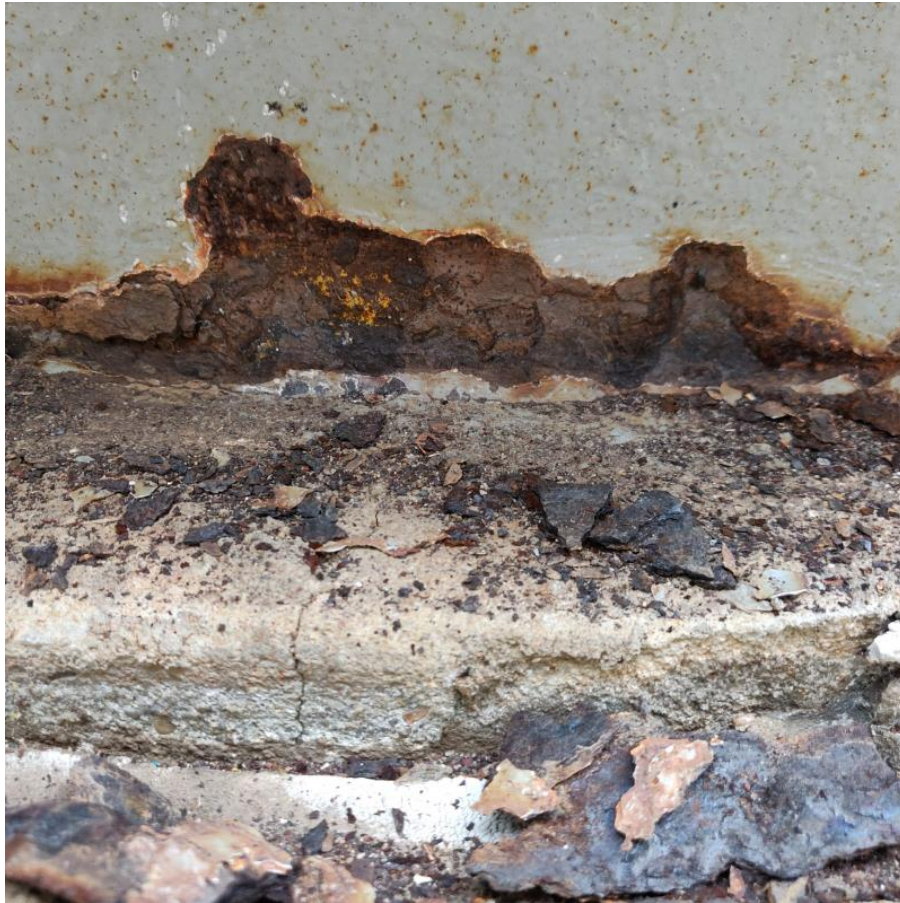
Coating Failure where Circulating Water Line comes out of the ground

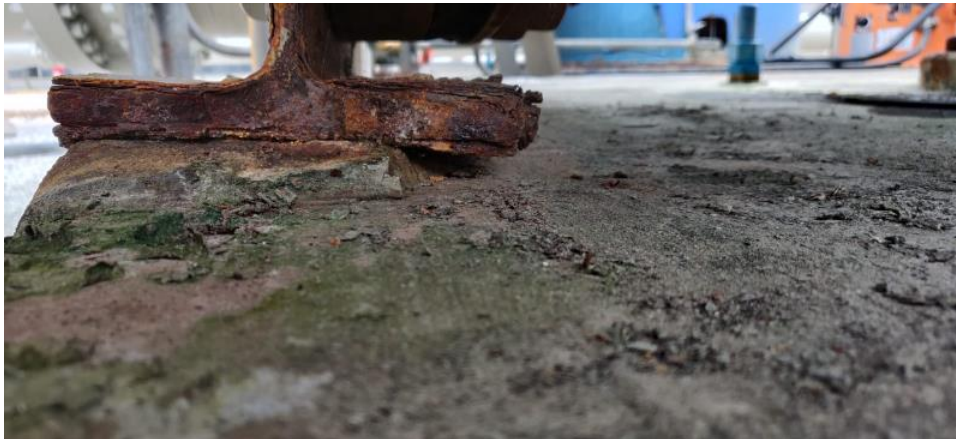
Side view of I-beam support with active corrosion

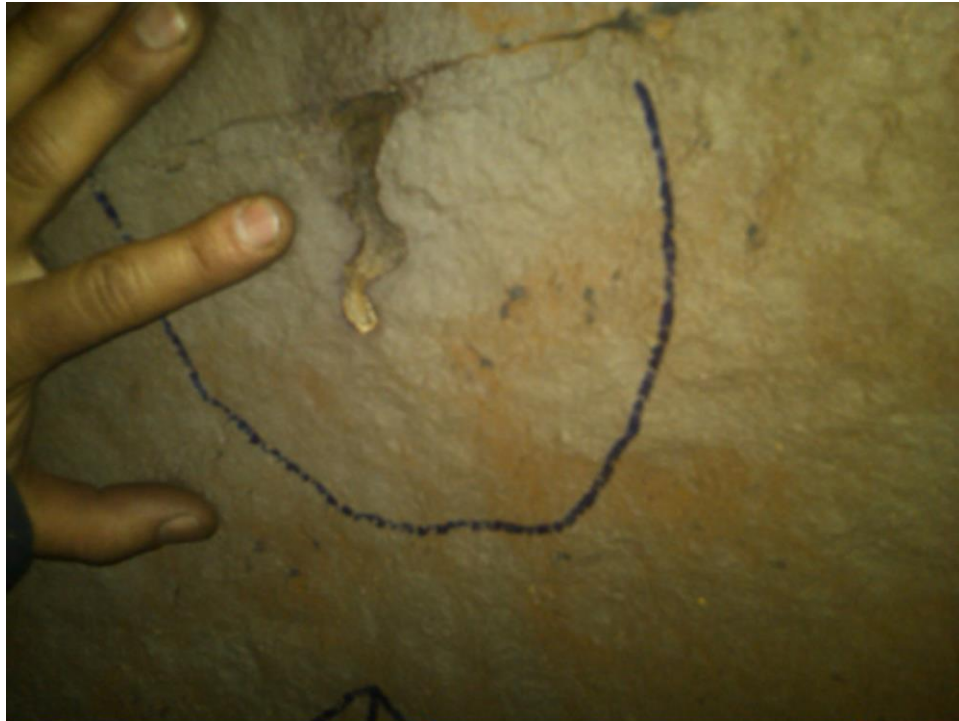
A hole found in a Circulating Water Line where it penetrates the concrete basement floor. The concrete had prevented this line from leaking.

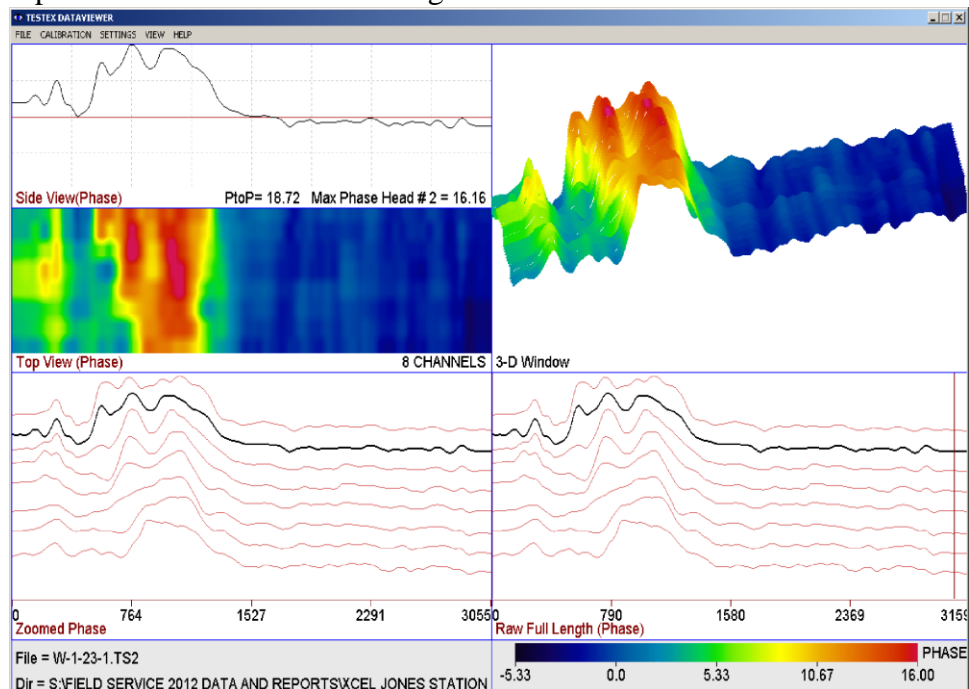
LFET waveform showing a hole in Circulating Water Line where it penetrates the concrete floor.
