Paper #: Power2008-60056

IMPROVING BOILER RELIABILITY THROUGH NDT

Shawn Gowatski
TesTex, Inc.
Pittsburgh, PA, USA

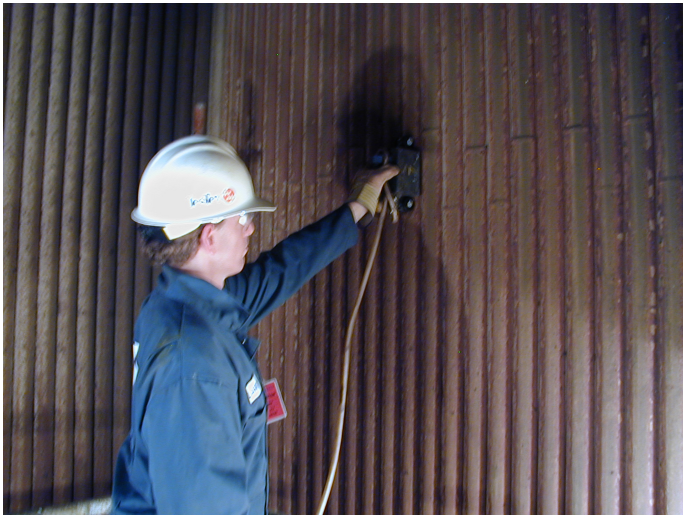
Figure 3 shows a LFET Inspection being performed on a water wall

There were 10 boiler tube failures in 1999 due to hydrogen damage. During one of these forced outages, TesTex was called to the site to perform a LFET inspection in a small area that was accessible from floating scaffolding. Approximately 1800 linear feet¹ was inspected with LFET on the North Wall. The LFET inspection found 11 existing defects.

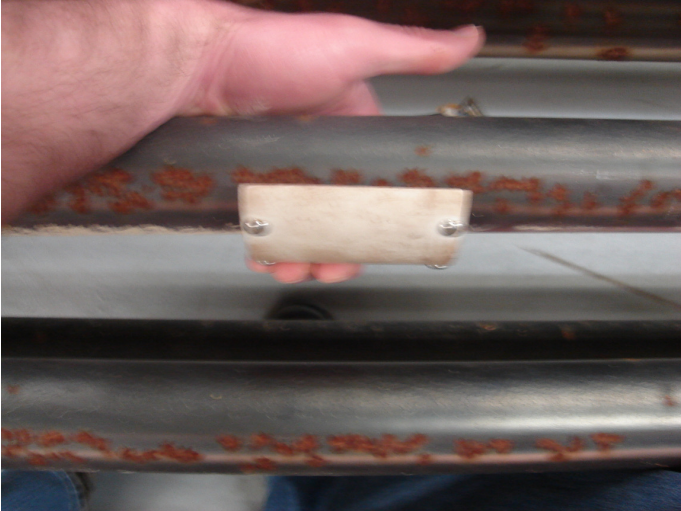
Figure 7 shows the Low Profile LFET scanner in a reheat bank.

Once the unit was offline, the reheat section was blown down with air to remove the ash. The inspection focused on five different areas that were accessible where the past failures had occurred. The scanners were able to inspect three tubes deep into the bank without having to spread the tubes.

A total of 44 defects was found. The defects were marked. The areas with the most severe flaws were removed. Minor defects were pad welded. The low profile LFET scanners were able to identify pitting as shallow as 20% wall loss or a wall remaining of 0.144" out of 0.180". Some tubes had several pits over a 4' area while other tubes only showed a single pit. The repairs the plant made saved them from several forced outages.
