CIRCULATING WATER LINE INSPECTION FINDINGS

TesTex has been performing inspections on Circulating Water Lines for power plants. The inspection consists of an API 570 certified piping inspector conducting a thorough visual inspection internally and externally as access permits. Ultrasonic thickness measurements are taken where accessible.

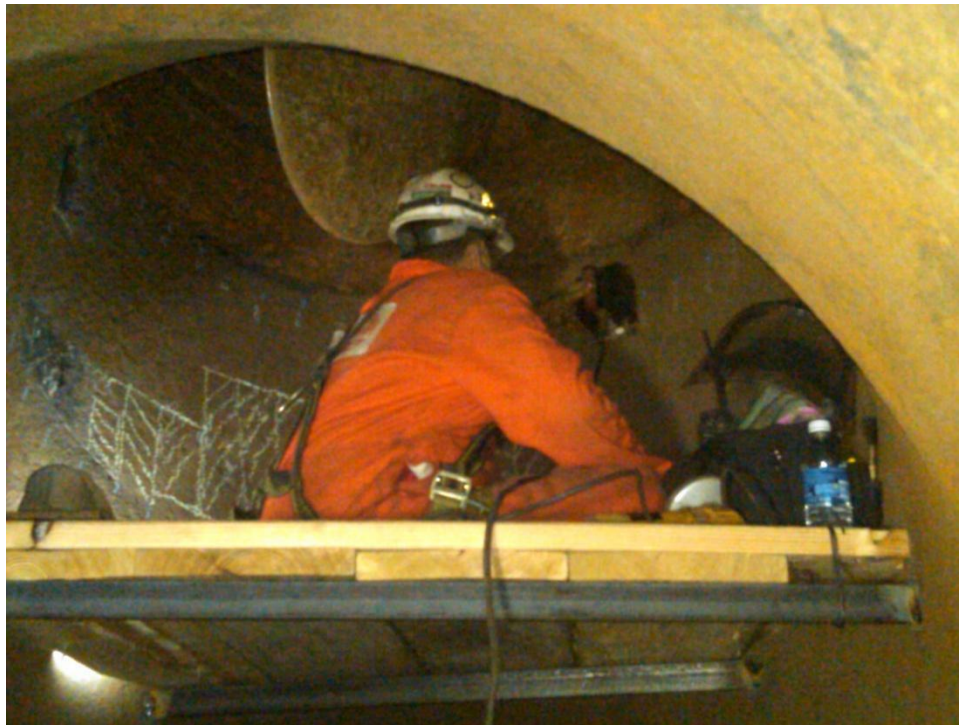
The picture above shows a technician scanning the Circulating Water Line where it penetrates the concrete basement floor.
